EMSWORTH LOCKS AND DAMS OHIO RIVER MAJOR REHABILITATION EVALUATION REPORT

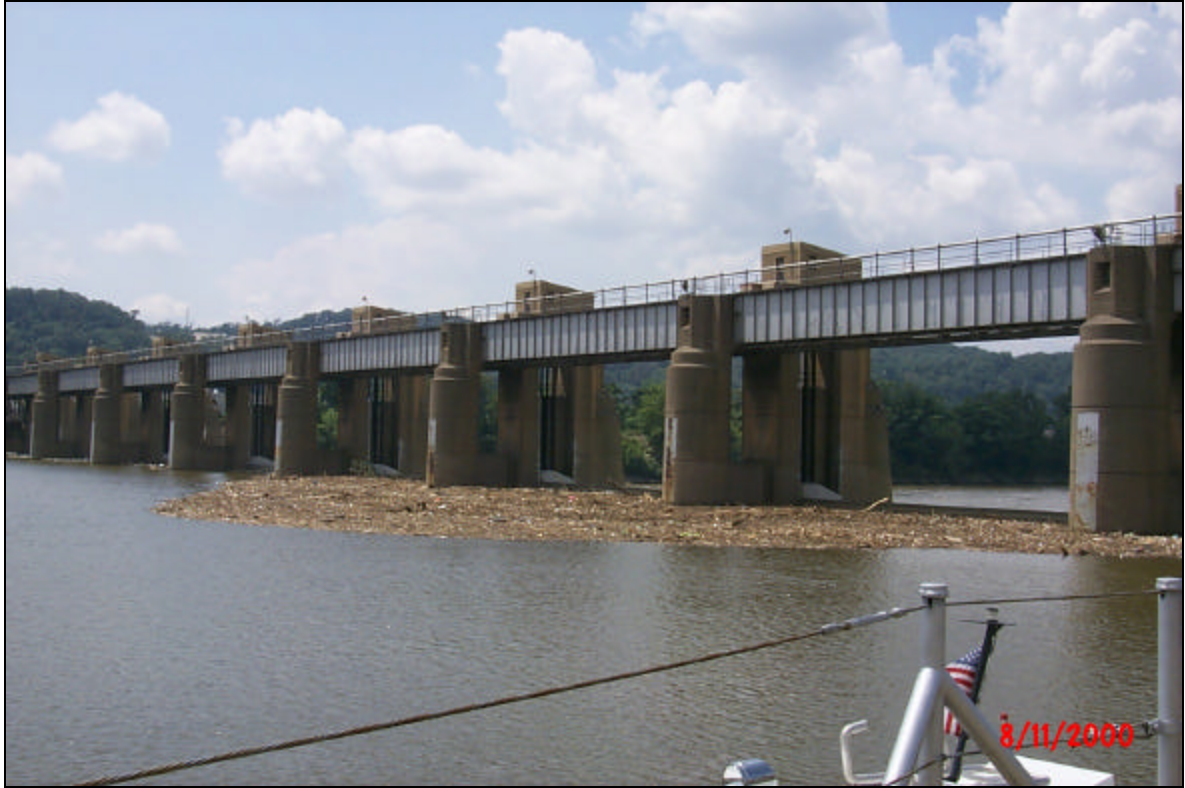
Photo II-1 - Emsworth Main Channel Service Bridge

The main channel service bridge is shown as Photo II-1. The service bridge for each dam consists of two built-up plate girders spaced at eight feet center-to-center. The bridge is categorized as “fracture-critical” by the Federal Highway Administration (FHWA) standards, due to non-redundancy in the superstructure design. Each service bridge utilizes a reinforced concrete deck to span between the two main girders. Crane rails are attached to the top flange plates of the main girders, which act as a track to carry the locomotive crane. A monorail beam for the bulkhead crane is connected to the underside of the downstream bridge girder flange plates.

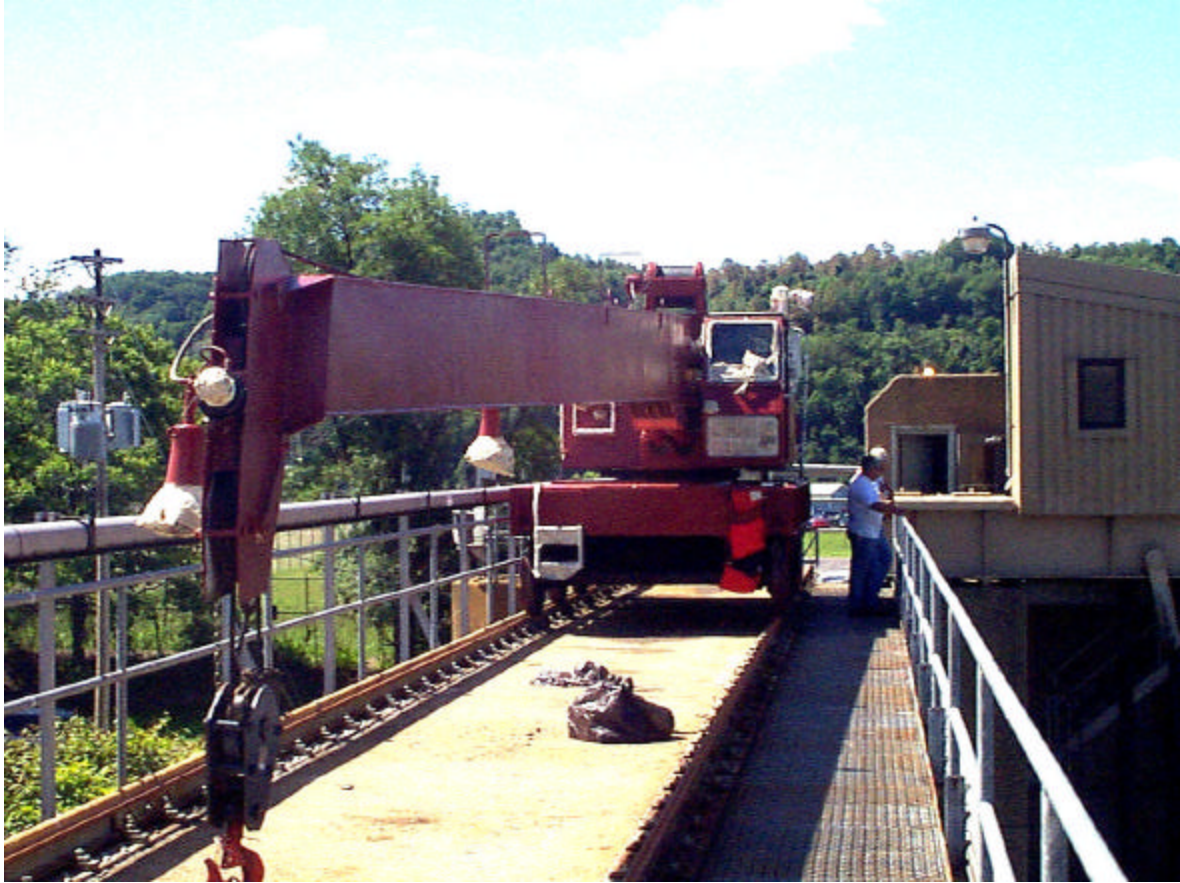
Photo II-2. Emsworth Main Channel Locomotive Crane

The main channel locomotive crane is shown in Photo II-2. Each service bridge is equipped with one locomotive crane. The crane rails are positioned along the top flanges of the upstream and downstream girder. Steel plate spacers are used to elevate the rails above the rivet heads (staggered along the top flange plate), and steel clips are used to secure the rails. . The locomotive cranes are used for servicing and repairing the lift gates.

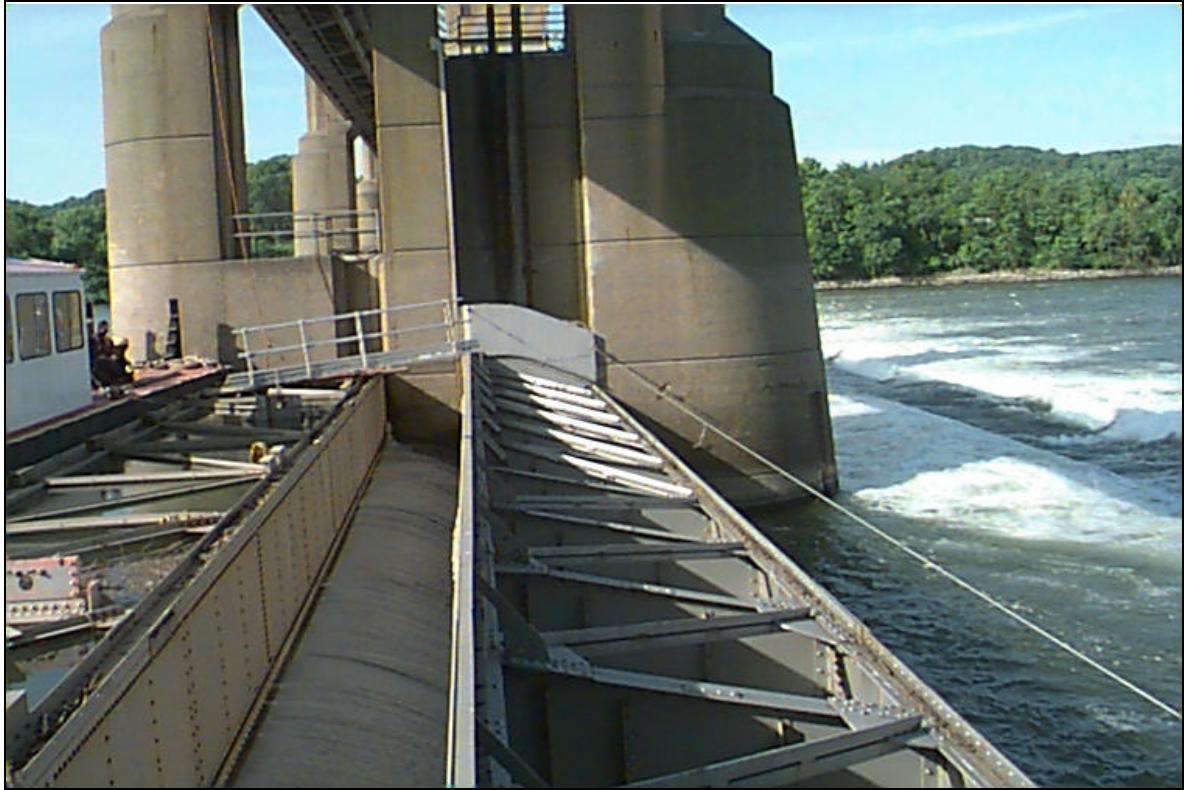
Photo II-3. Emsworth Vertical Lift Gate Truss Assembly

The vertical-lift gates were repaired and modified prior to and during the 1981-83 Major Rehabilitation project. Prior to this Major Rehabilitation, the overflow feature of the vertical-lift gates was removed. Overflow sections attached to the top truss were removed and replaced with a skin plate extension, which was added to the upstream face of the top truss. Also, the gate sills were modified to provide a seal surface. During the Major Rehabilitation, the gates were further repaired according to field inspection and determination of structural integrity of members and rivets.

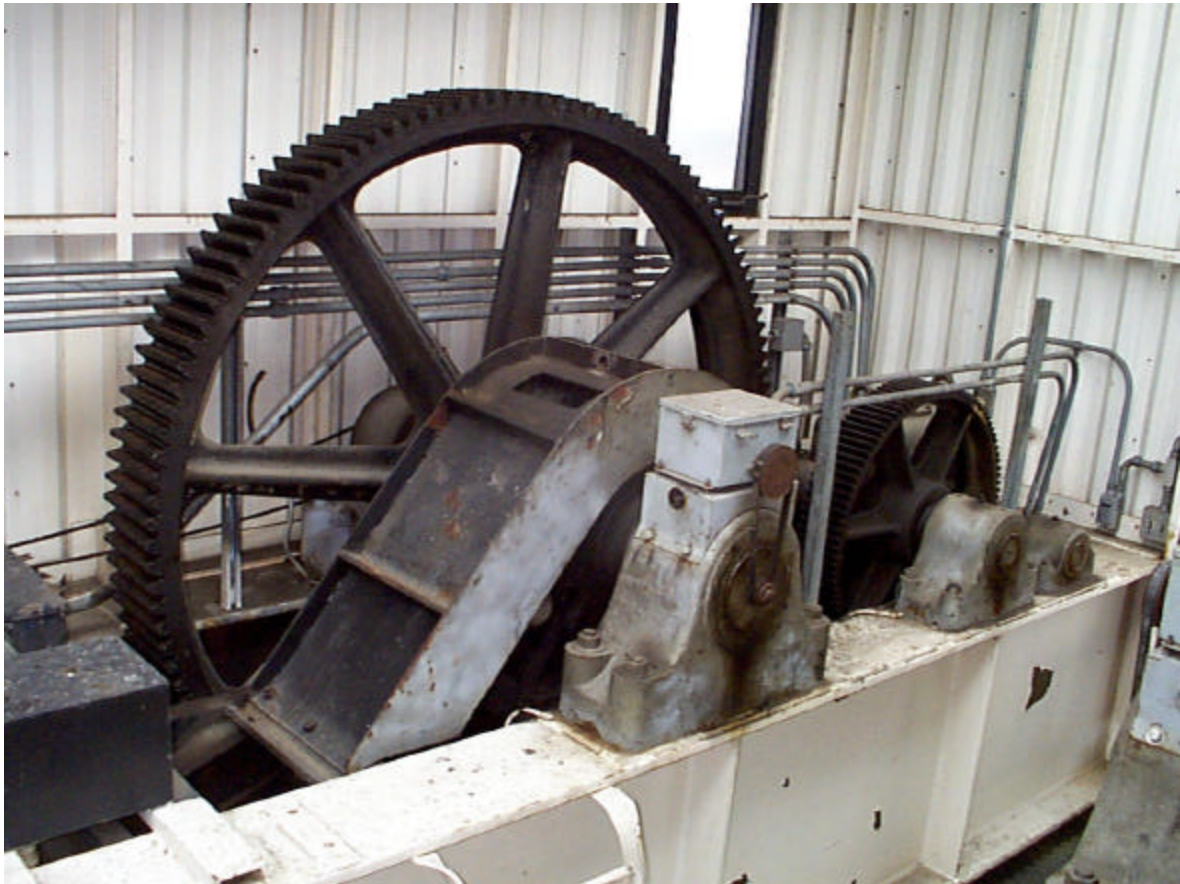
Photo II-4. Emsworth Vertical Lift Gate Machinery

The vertical lift gate machinery for each gate is comprised of two independent systems. Each system is comprised of one roller chain attached to the end of each gate and a hoist located in a metal housing directly overhead. The hoist machinery located in one housing is shown in II-4. Each hoist consists of 2 sets of spur gears, a helical gear set, a secondary reducer, and a worm gear primary reducer driven by synchronous-type wound rotor electric motor. The motors must maintain the gates at a nearly level position throughout their range of travel. A travel limit switch is provided at one end of each gate to prevent over-travel.

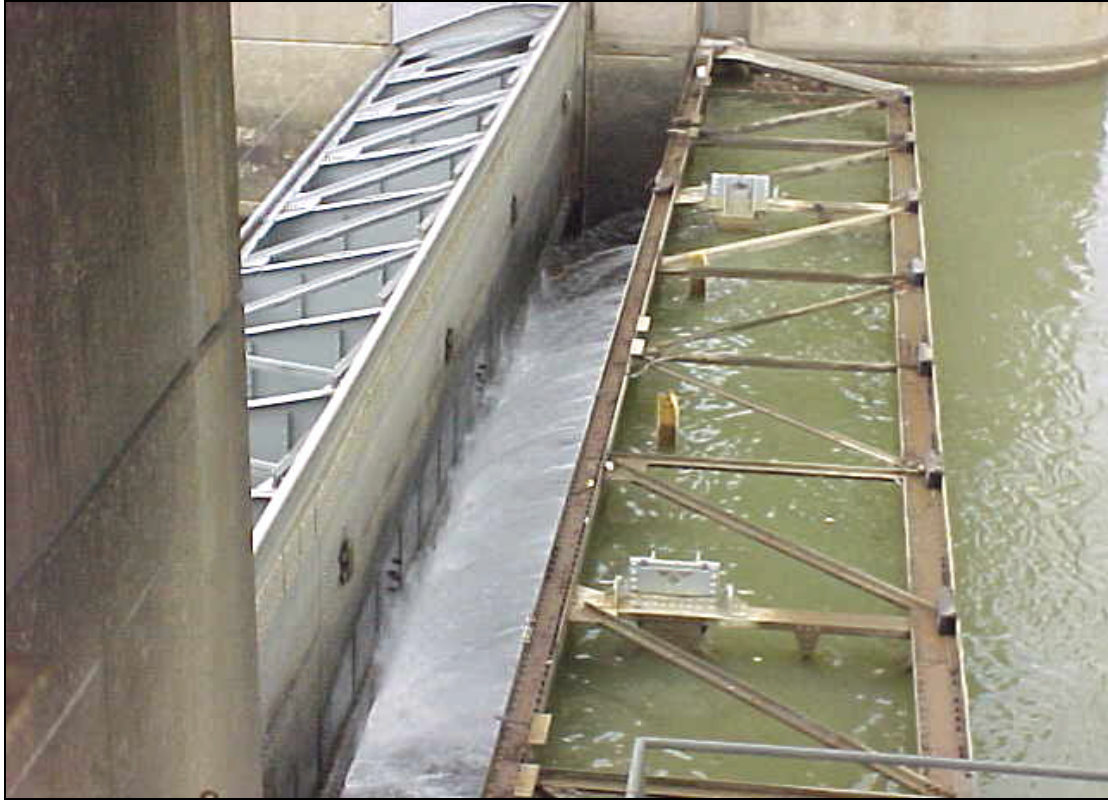
Photo II-6. Main Channel Emergency Bulkhead

Each dam is equipped with one emergency bulkhead assembly to accommodate closure of one gate bay and are designed to be installed under flowing conditions. The main channel emergency bulkhead is shown in Photo II-6. Each assembly consists of four sections that are stored in pits near one abutment. Each unit consists of a top and bottom truss, with a damming height of 4' 2 1/2", and is framed to withstand horizontal forces and vertical dead loads. The trusses are built-up sections with a back-to-back angle depth of 11' 7 3/4". The overall length of the bulkhead sections is 102' 3 1/2" centerline of roller to centerline of roller. The bulkhead sections are made of structural-grade aluminum alloys and are of riveted construction. Placement of the bulkhead units in a Gate Bay is performed by means of an electric motor-driven hoist, which travels suspended on a monorail track attached to the bottom flange of the service bridge downstream girder and through slots in the dam piers. The hoist retrieves one unit at a time from the storage bay, travels to the placement bay and lowers the unit into place.

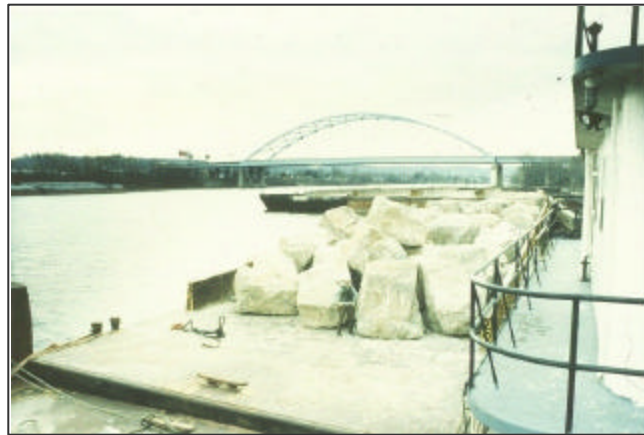
Appendix A, Section A.4. The floor and apron was selected and designed after a series of physical model tests by Carnegie Institute of Technology had given the most satisfactory ratings in velocity measurements and scour observations. During the Major Rehabilitation in the 1980's, the stream bed immediately downstream of the dams' aprons was graded, shaped and scour-protected with a heavy blanket of 5' derrick stone over a 3' graded stone blanket and a 1' filter blanket. Scoured areas upstream of the main channel dam were similarly filled, and stone protection was added. The graded stone is shown in Photo II-7.

Photo II-7. Stone Blanket Material
